# **Integrated structural safety analysis of San Francisco Master Gate in the Fortress of Almeida**

*Abstract* – After more than three hundred years of being exposed to human and nature actions the Master Gate of San Francisco in Almeida, Portugal, has sustained visible extended damage. Although its importance, as a historical monument, is undeniable, no attempts have been done so far to determine its level of safety. In this paper several models are developed in order to achieve this goal. A brief description of the Gate's history is presented followed by a summary of the inspection and diagnosis procedures employed in this study and the results obtained from them. Later the type of numerical models selected are discussed as well as the methodologies used to represent damage. Finally results from the numerical models are presented in a first attempt to identify the safety level of this historic construction. Results indicate that although the structure has lost a great percentage of its original capacity is still safe.

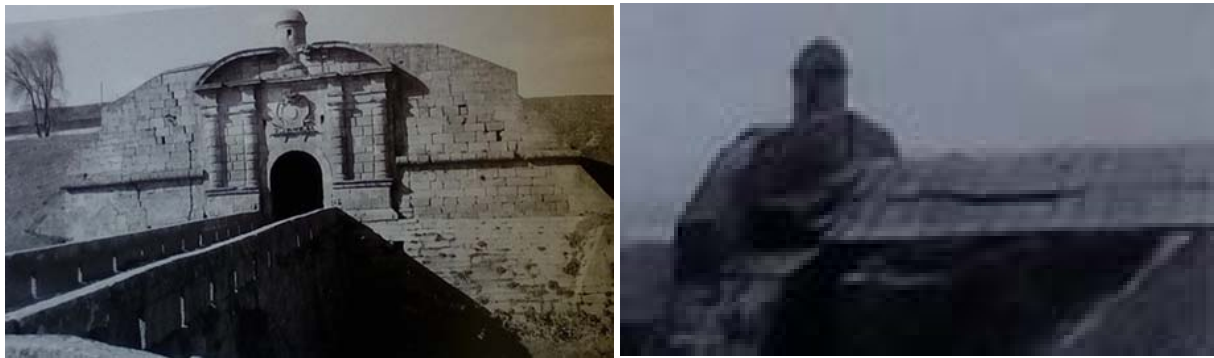
The French invasion in 1810 will pass down in history as the most destructive event both for the fortress and the Gate of San Francisco. The explosion of the gunpowder storehouse destroyed the castle and generated great damage to the fortress and specifically to the Gate of San Francisco. The bombing due to the siege did a huge contribution as well. By 1815 the order to start reconstruction works on the gate was issued but since the war was over in 1814 the urgency of reconstruction was low and the construction works were kept to a minimum. It was not till the 60's of the 20<sup>th</sup> century that a significant restoration project would take place. The Figure 3 shows the gate by that time. Notice the wide crack with deformations on the right picture.

Figure 3. State of damage in the Gate of San Francisco year 1962: at left the main facade with vertical cracks and loss of material; and at right a crack on the roofing system (stone roof).

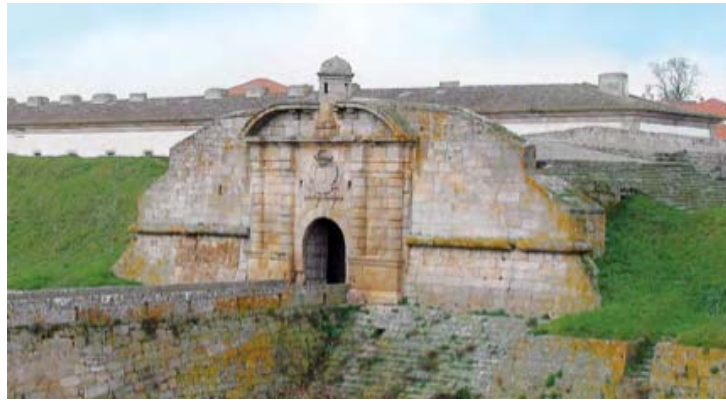
Figure 4. State of the Gate of San Francisco by 2016.

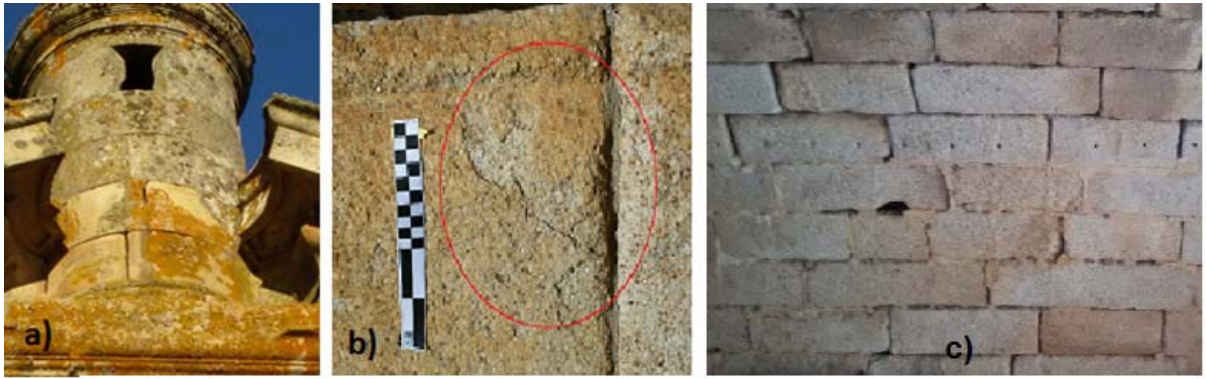
Visual inspection allowed to identify numerous pathologies both structural and nonstructural. In the nonstructural category the presence of lichens were identified, being part of the “Nitrofilos” family, a species that benefits from deposits of nitrogen and dust to grow (Barros, 2016). It is very likely that this lichens benefit from the nitrogen that is carried out of the soil fill in the walls and that is probably washed out by infiltrated water. Vegetation growth was also identified. Additionally, the loss of superficial material in the granite stones, humidity stains and the presence of salts at the stones surface inside the transit tunnel were observed (Figure 12).

Figure 12. Non structural afectations in the Master Gate of San Francisco: a) lichen attack; b) spalling of the granite stones; and c) humidity stains.

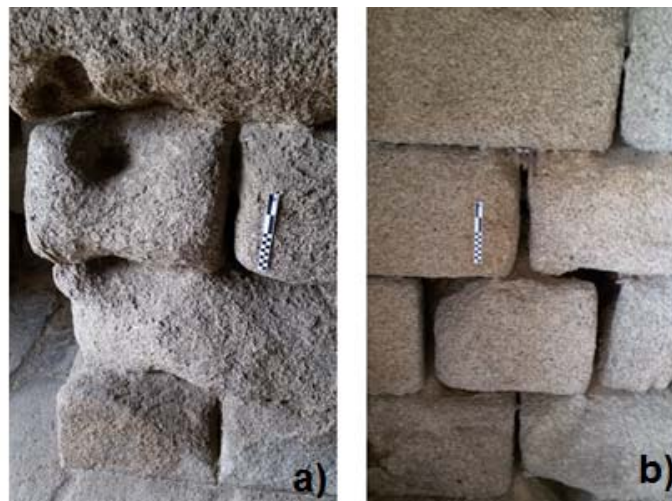
The main structural concerns are the great loss of material in the joints (Figure 13) and the loss of material in the granite blocks used for the stone masonry. Material erosion could be related to a combination of the presence of salts and water.

Figure 13. Deep degradation of granite stones and loss of the mortar in joints: a) at the base of the wall; and b) on the intrados of the vault.

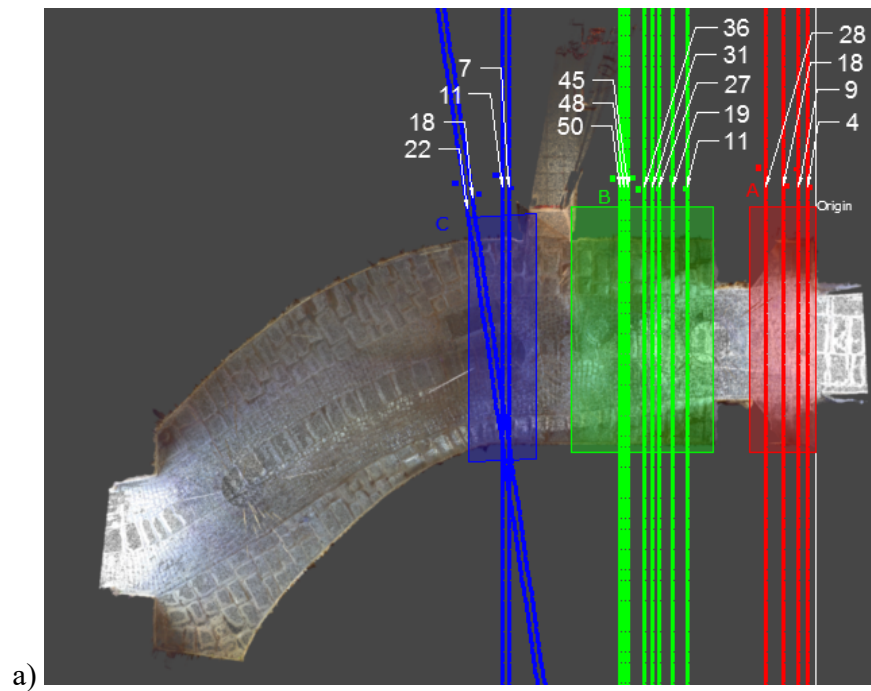
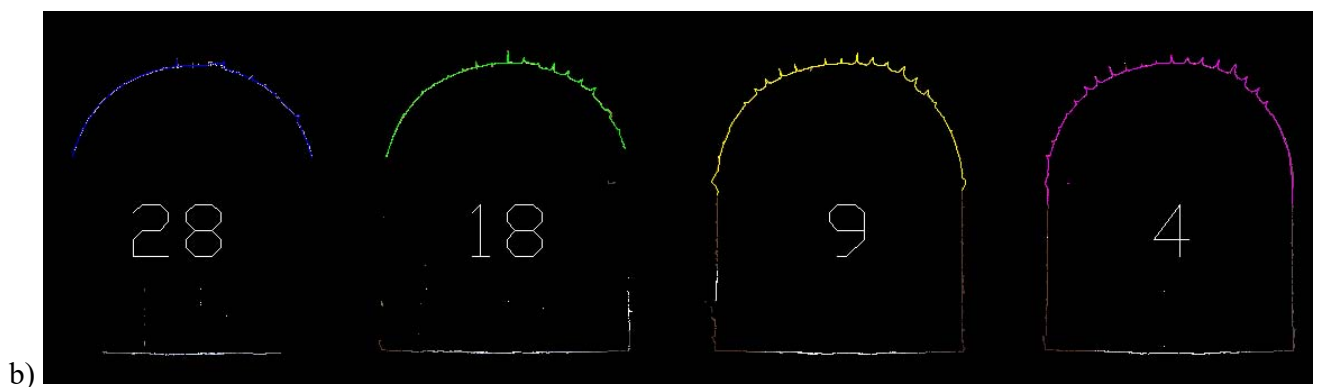
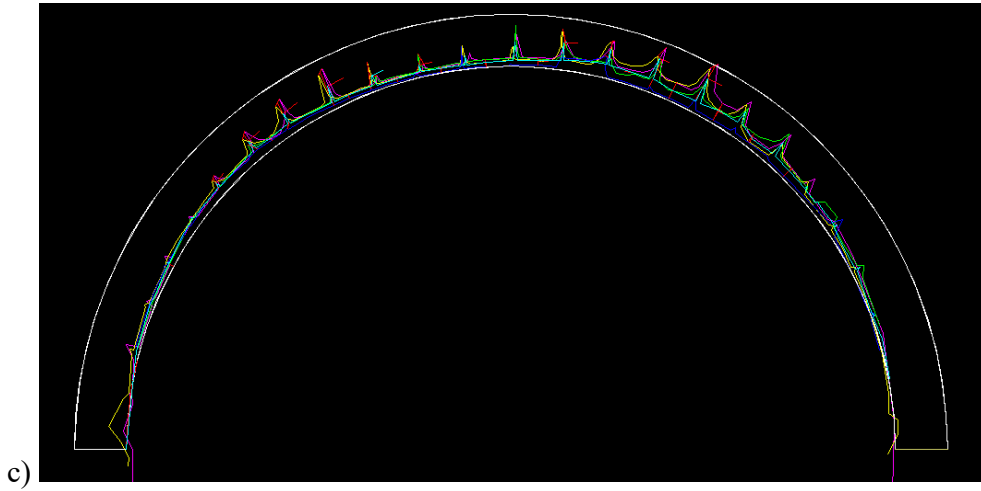
The loss of material in the joints between the voussoir stones seems severe, according with the results provided by the TLS point cloud (Figure 9). A number of 28 2D sections extended through the tunnel depicts precisely the loss of material in each joint (Figure 14a). The profiles from the area close to the

entrance of the gate (zone A in red) showed the highest level of deterioration and therefore were selected for the further numerical analysis (Figure 14b). In this area, the damage is characterized by the loss of the material but also by the alignment in plane of the joints with higher level of deterioration, which increases the risk of failure. Figure 14c shows a superposition of the cloud of point 2D profiles in Zone A which then would be used as a base for modelling the damage in the structure.

Figure 14. a) Laser scanning testing zones A (Red), B (Green), C (Blue). b) Damage profiles from clouds of points for Zone A c) Superposition of the most damaged profiles and resultant vault considered for the numerical simulations.

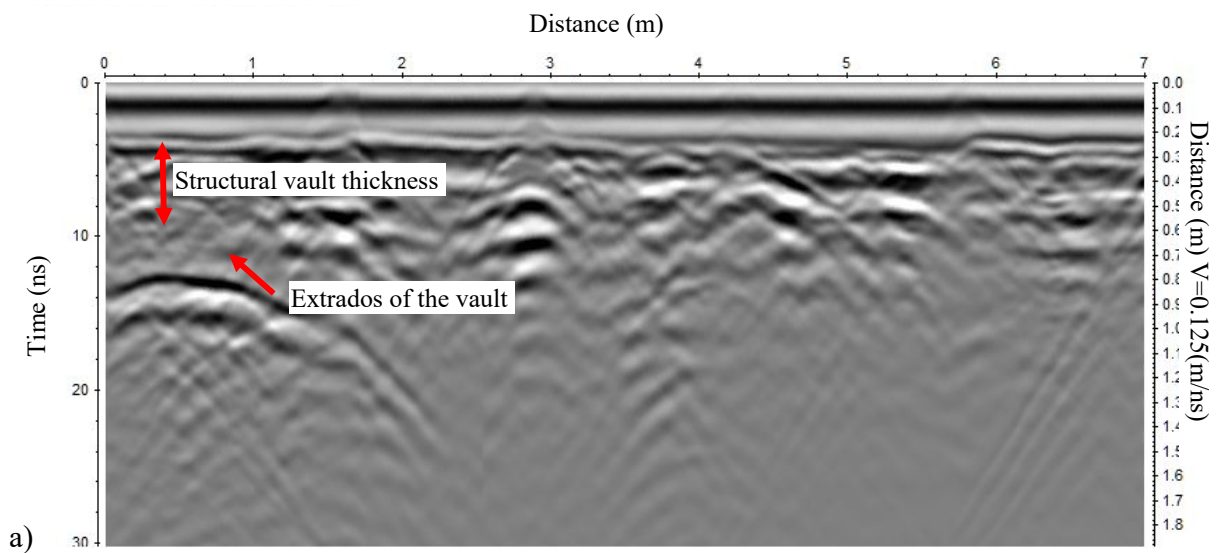
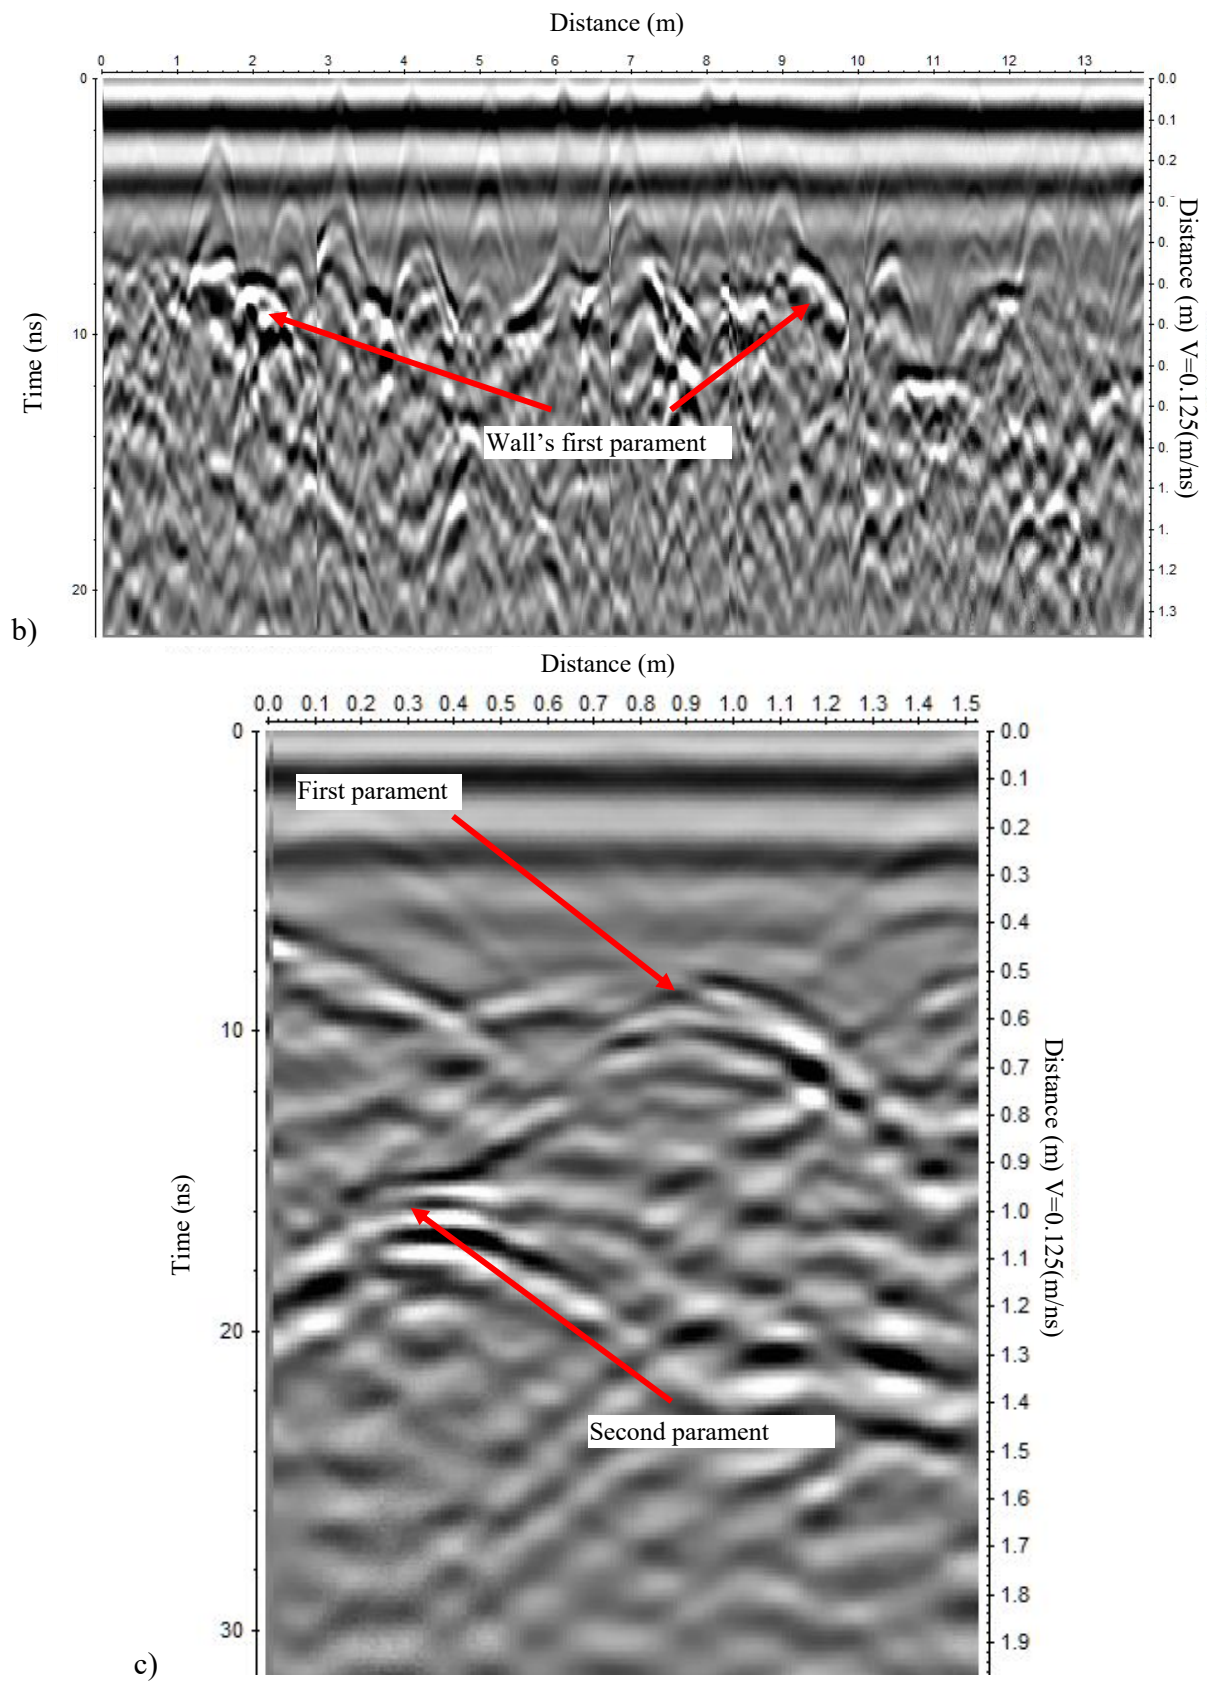
Figure 15 illustrates two radargrams that resulted from the survey to the vault and to the masonry walls along the tunnel. The inspection of the vault resulted in an average thickness around 35 to 45 cm. The wall survey showed the first parament of an irregular masonry multi-leaf wall. This first leaf exhibits an average thickness of 40 cm, although the thickness should be much larger, up to 1 m, as indicated in the last part of the radargram Figure 15b and c.

Figure 15. Radargrams illustrating the charaterization of the vault (a) and the masonry walls with horizontal (b) and vertical (c) profiles.

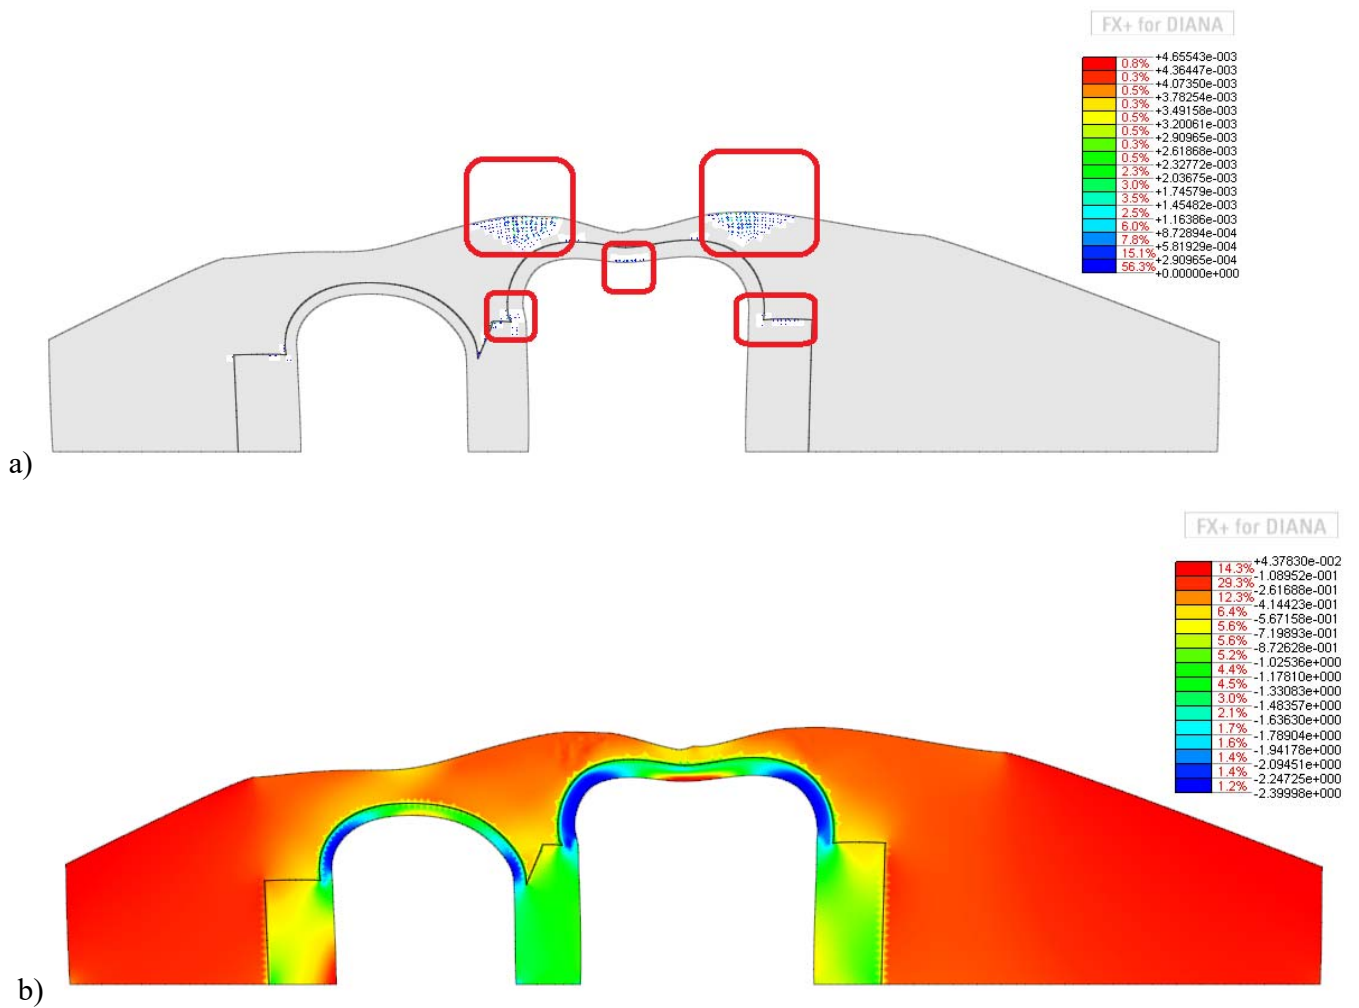
Local failure occurs in the structure by the collapse of the right barrel vault in which five hinges are formed before failure. Results from crack pattern analysis clearly show a severe damage in the middle of the intrados of the vault (Figure 20a). This effect, combined with the crushing of material by compression on the sides (as seen in the blue areas in Figure 20b) results in excessive deformation in the vault and the

generation of a local mechanism of failure. At failure, the compressive stresses have reached the maximum value of the material capacity, i.e., 2.4 MPa. So in this case, the stone masonry material that composes the supporting structure reaches the limit capacity in the right vault, specifically in the base of the vault as it is depicted by the blue colored zone in Figure 20b. The failure mechanism is reached by crushing of the material in the base of the vaults without producing important damage at the base of the columns.

Figure 20. Structural response to an ultimate live load of 245 kN/m a) Crack locations b) Principal compressive stress [MPa].

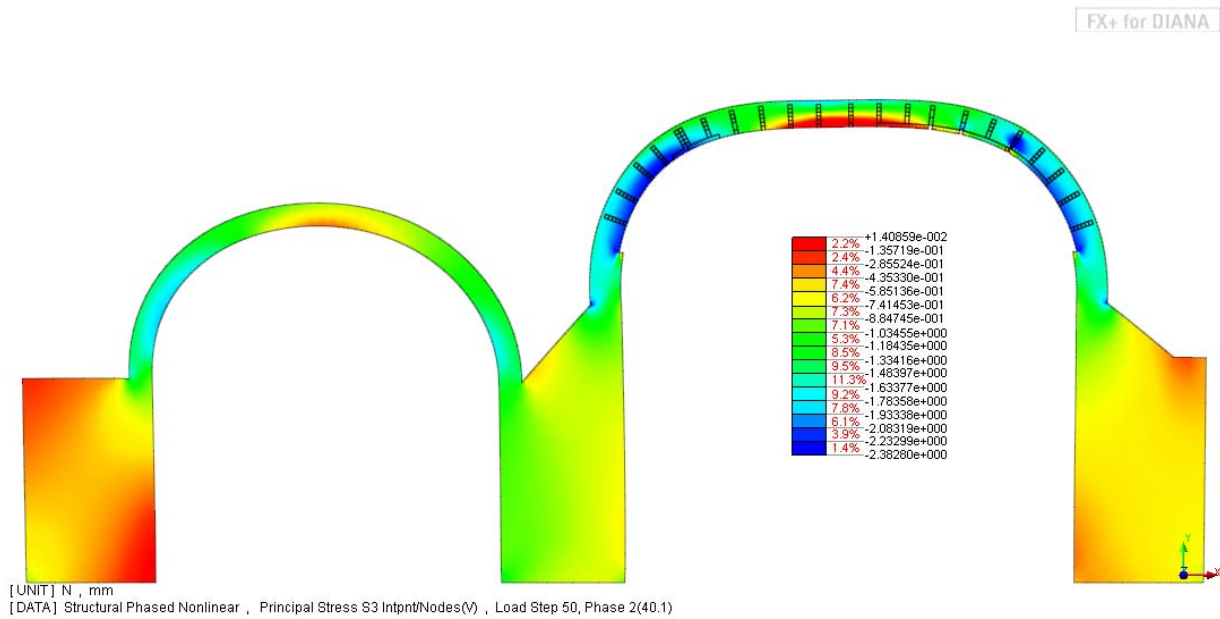
The first step implies the removal of the most exterior layer of elements in the intrados of the vault (Figure 18b). This results in a higher concentration of compressive stresses in the vault and a general reduction of the maximum load the structure can resist. Load factor decreases from 49.0 to 40.1 (Figure 26), which represents around 20% of loss in the structure's ultimate capacity due to a general loss of material of 5 cm in the intrados of the vault (12.5% of the thickness). Figure 23 shows the compressive zones in the base of the vault where the crushing of the material occurs. Note that the compressed zones are not focalized but evenly distributed along the intrados base of the vault.

Figure 23. Principal stress  $\sigma_3$  for symmetrical live load Phase 1 [MPa]

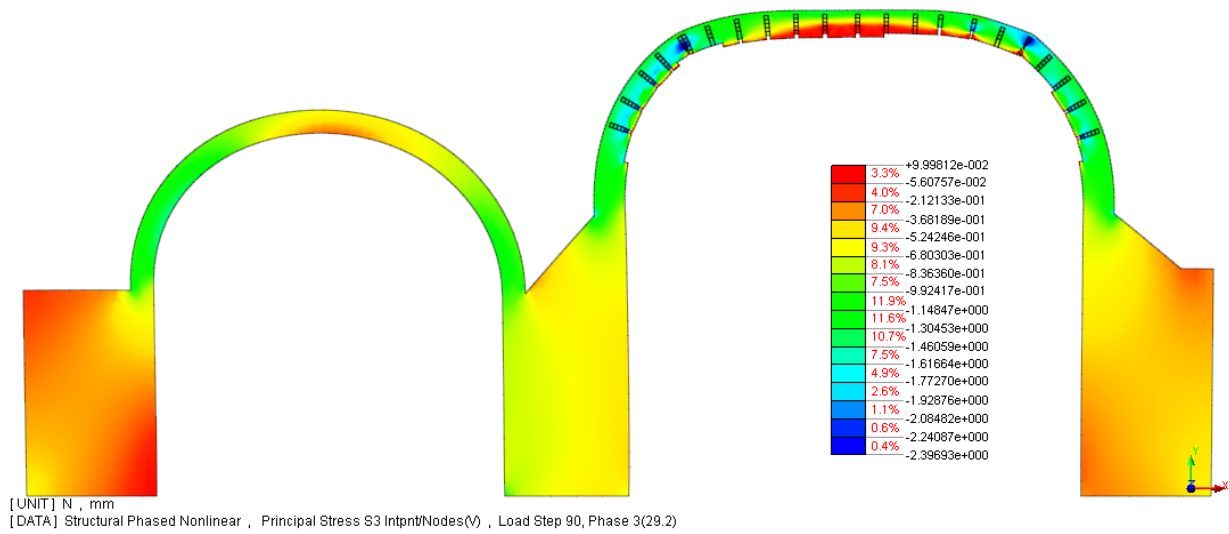
By removing the second section of elements (Figure 18c), the ultimate factor lowers a total of 40%. Almost half the capacity of the structure has been lost at this stage and this model does not even represent the current level of damage. Anyway the load factor has lowered to 29.2 which is still extremely high, indicating that even though half the capacity has been lost the structure is still safe. Figure 24 shows the principal compressive stresses for this load factor. The biggest change in comparison with the previous step is the concentration of compressive stresses on much localized areas in both the left and right on the top of the vault.

Figure 24. Principal stress  $\sigma_3$  for symmetrical live load Phase 2 at a load factor of 29.2 [MPa]

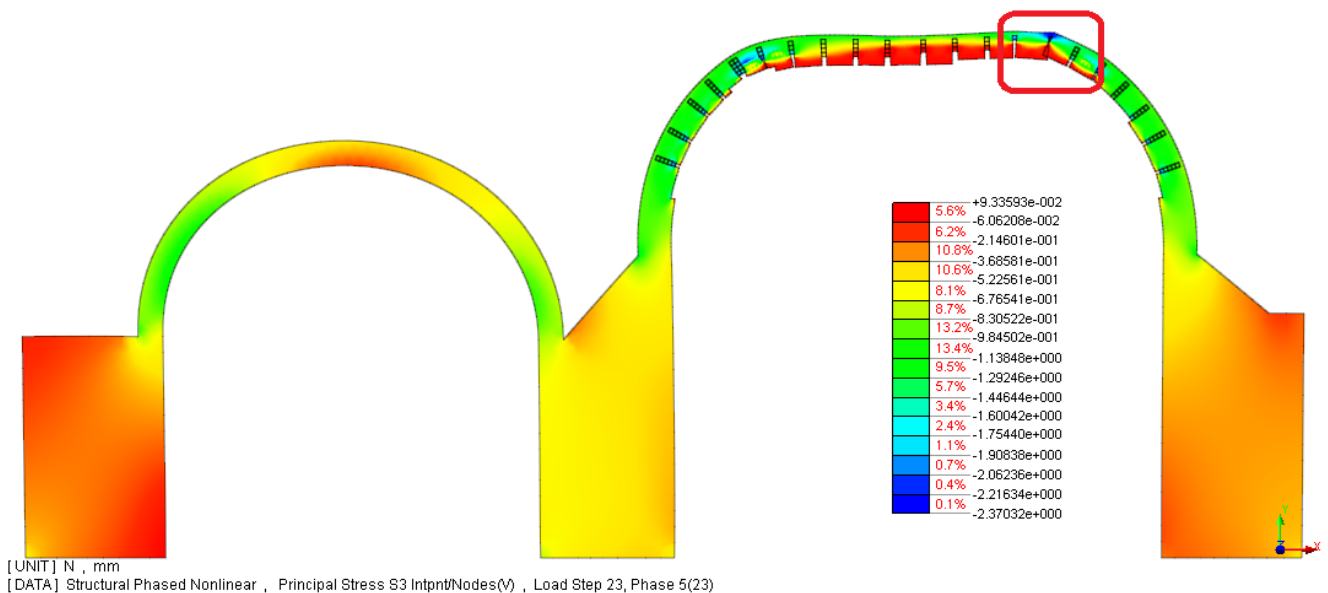
In the final step the removed elements (Figure 18d) leave a structure that resembles the most the current state of deterioration. A high compressive hinge is clearly formed on the top right of the vault (Figure 25), where crushing of the material would most likely occur. The load factor has decreased from 49 to 23 resulting in a loss of capacity of 53%. Even in these conditions the structure can be considered safe, as the load factor of 23 represents a loading condition of 23 times 5 kN/m<sup>2</sup>, which equals to 115k N/m<sup>2</sup>.

Figure 25. Principal stress S3 for symmetrical live load Phase 3

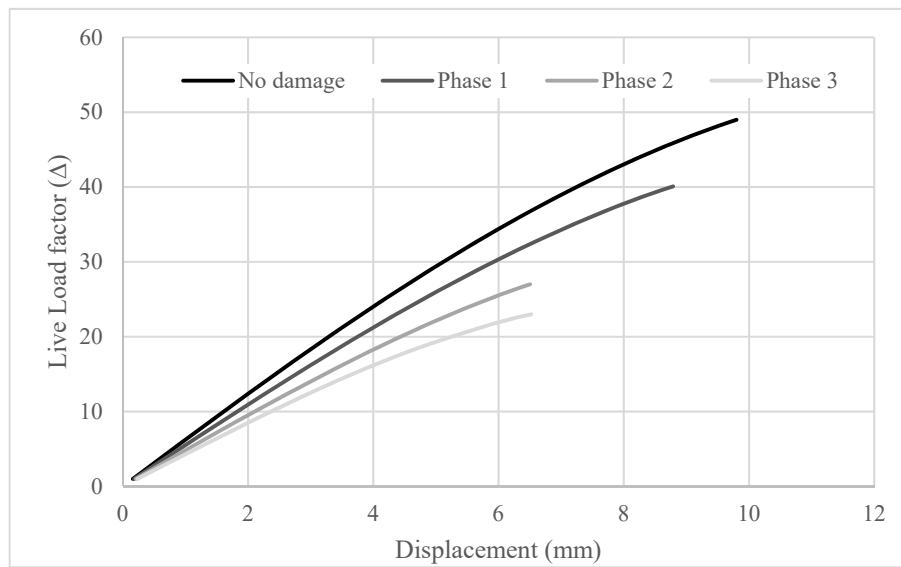
Figure 26 shows a comparison of the different levels of damage with respect to the original state of the structure. Notice how the increase of damage in the vault results in a loss of stiffness of the structure as the slope of the curve becomes lower each time a group of elements is removed. The load factor shows a significant decrease as a result of the deterioration, original factor for failure due to the increment in the live load factor was 49 and for the Phase 3 this value has been reduced to 23 equivalent to a live load of  $115 \text{ kN/m}^2$ , less than half the structure original capacity remains.

Figure 26. Load vs displacement curves for phased live load analysis.
